# Manhole Inspection Summary

Manhole # S35SS1002MH

**Location** Address: **5119 UNDERWOOD RD**

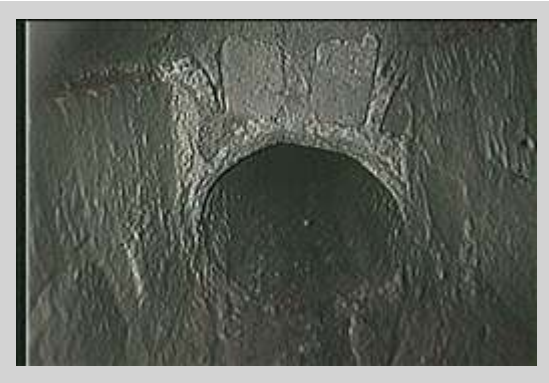
### 8 in. Circular Gravity Sewer Pipe Out @ 12 O'Clock

Pipe Material: **Clay** ☐ Pipe Lined

Infiltration: **None** Pipe Seal Cond: **Unknown**
